Engineering Fracture Mechanics
Prof. K. Ramesh
Department of Applied Mechanics
Indian Institute of Technology, Madras

Module No. # 01
Lecture No. # 02
Spectacular Failures

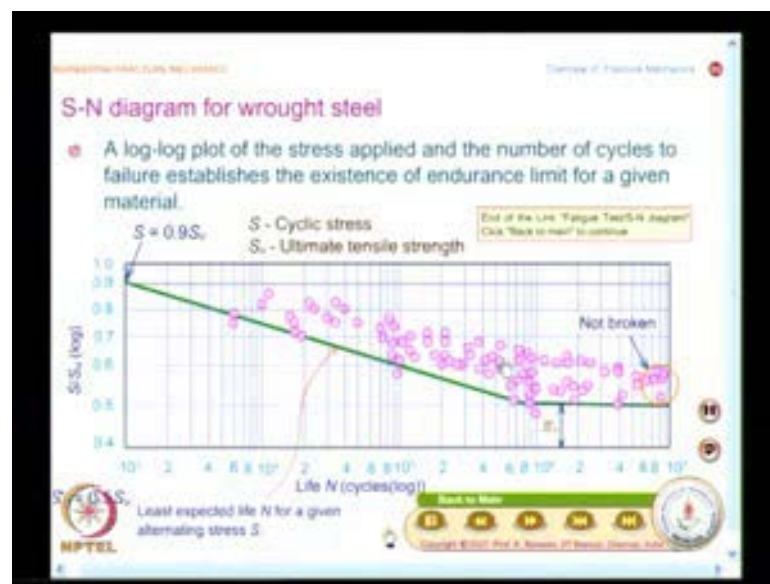
(Refer Slide Time: 03:35)

And what you find here is you are in a position to draw a line like this; that gives the least expected life N for a given alternating stress S . And, you also have from a design point of view, a convenient parameter call the endurance limit. So, what you find is, if you load the specimen, only to the endurance limit, it gives an impression that, you will have infinite life without any problem. It is very convenient parameter from design point of view. See, the modern research tells, there is nothing like endurance limit for any of the material. Every material fails after sufficient number of cycles.

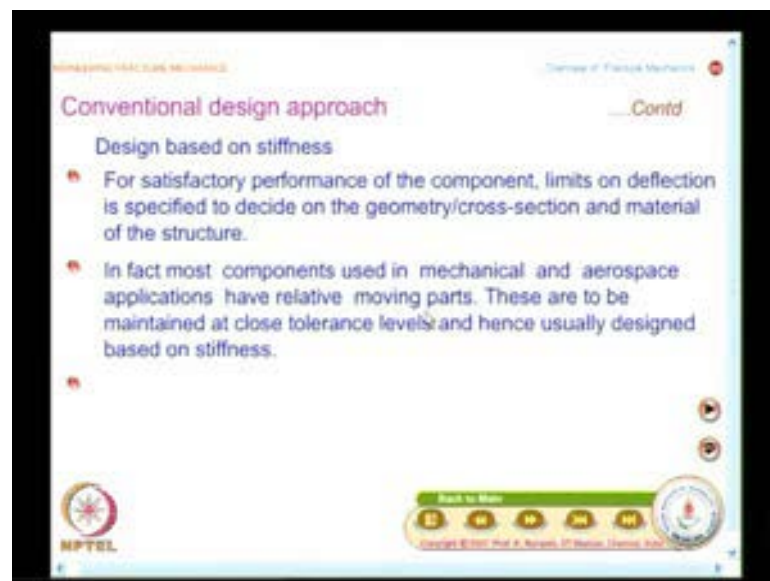
(Refer Slide Time: 13:56)

So, the focus here is, when I have relative moving parts, the deflection or deformation plays a very important role. Because you have to maintain close tolerance levels and usually designed based on stiffness.

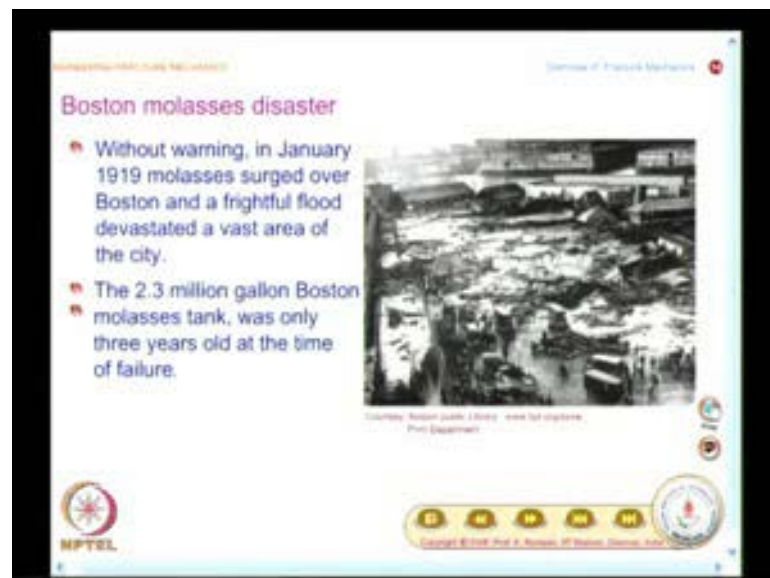
(Refer Slide Time: 21:49)

So, what happened was without warning. That is the key aspect. See, you had seen a tension test; you take a mild steel specimen or a ductile specimen and pull it, you have always noticed, you have a questioning; it goes through extensive plastic deformation before it fails. So, you naturally conclude, when we make a structure out of a ductile material, it would give you some kind of a warning before it fails. What happened in the case of molasses disaster? Without warning, in January 1919, molasses surged over Boston and a frightful flood devastated a vast area of the city.

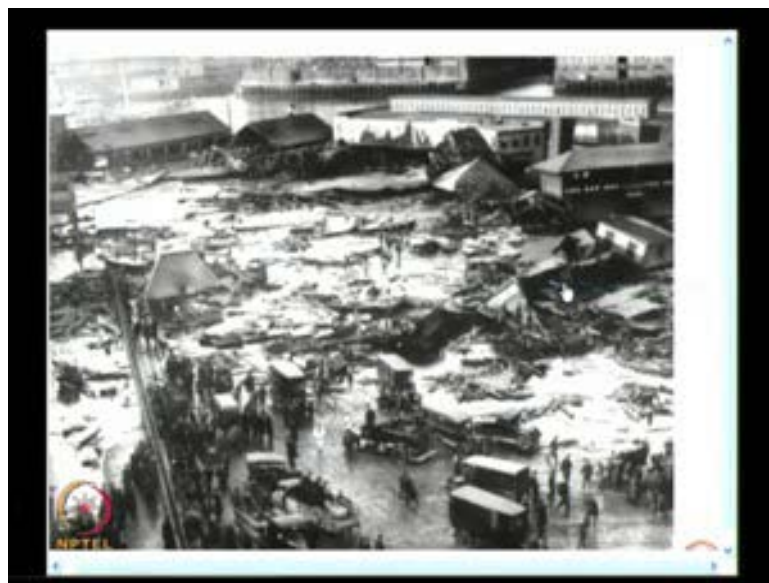
(Refer Slide Time: 23:44)

Just to give you a rough size and this also gives you, an idea of what is the kind of devastation that occurred and this figure, courtesy, is from Boston library.

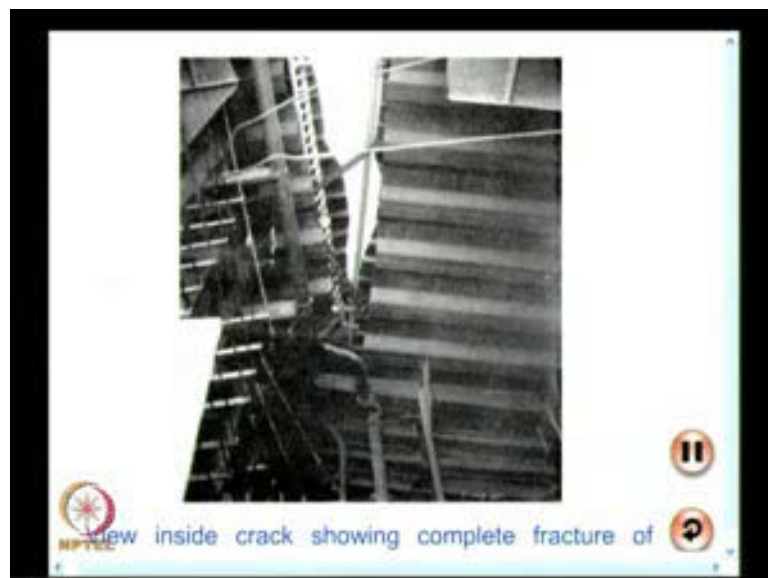
(Refer Slide Time: 36:31)

And if you really look at, the whole analysis started when you had this T-2 tanker Schenectady broke into two in the warm waters of, in the cold waters, you should not say warm waters, in the cold waters of Swan island and this is the tanker. This ship broke into two. You see the fracture here and this figure is from Project Liberty ship and what you had was, the water temperature was about 4.5 degree centigrade. Then the problem

was taken up seriously. And, this shows the fracture through the deck. You can see how the entire deck has fractured. It is a very serious matter.

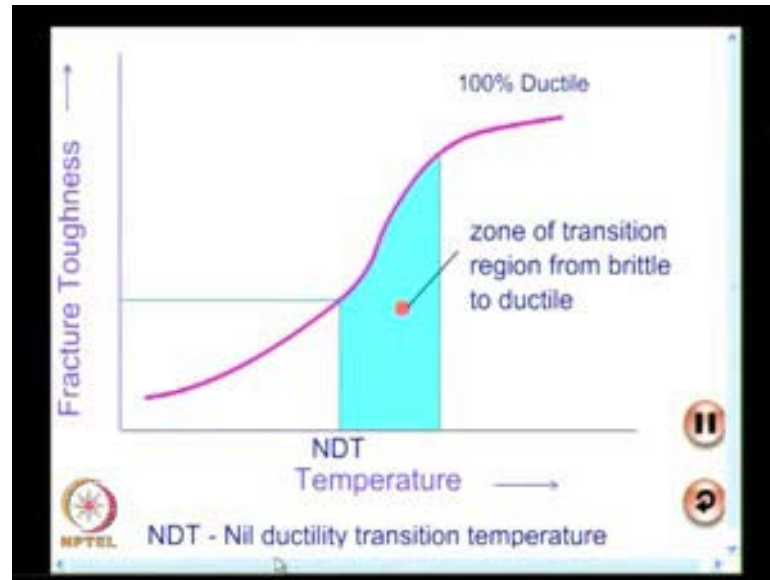
(Refer Slide Time: 38:07)

So, in this region, the material is 100 percent ductile; below this temperature, which is labeled as NDT, the expansion is nil ductility transition temperature. So, you find there is a transition zone, from ductile to brittle and what people have found is, I had already mentioned that, there are degradation mechanisms, particularly in nuclear power plants. People have to understand, how to safely guard the nuclear power plants; what they found was, when the structure is exposed to radiation, there is a drastic change happens on the nil ductility temperature. And people have understood and call it as a radiation shift.

So, what you find here is, the whole graph shifts to the right. So, this is called radiation shift and you find the nil ductility transition temperature has increased. So, that means, over a period of time, the nuclear power installation degrades because of exposure to radiation. This aspect needs to be taken into account at that design phase itself; that is what is important.
