Engineering Fracture Mechanics
Prof. K. Ramesh
Department of Applied Mechanics
Indian Institute of Technology, Madras

Module No. # 01
Lecture No. # 03
Lessons From Spectacular Failures

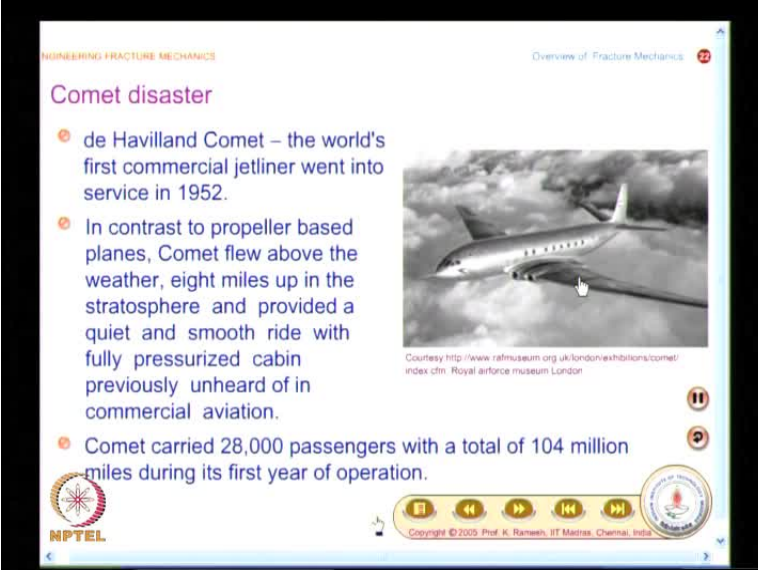
(Refer Slide Time: 01:02)

The slide is titled "Comet disaster" and is part of a presentation on "Engineering Fracture Mechanics". It features a photograph of a de Havilland Comet jetliner in flight. The text on the slide provides the following information:

- de Havilland Comet – the world's first commercial jetliner went into service in 1952.
- In contrast to propeller based planes, Comet flew above the weather, eight miles up in the stratosphere and provided a quiet and smooth ride with fully pressurized cabin previously unheard of in commercial aviation.
- Comet carried 28,000 passengers with a total of 104 million miles during its first year of operation.

Now, we look at the third spectacular failure. This is a comet disaster. De Havilland Comet, the world's first commercial jetliner went into service in 1952. See, what you will have to look at is – now, jet air planes are very common. So, you have to realize, that was the first jet airliner; so, many technologies have to be tried for the first time. So, from that point of view, the whole design was an engineering challenge.

And what is advantage of a jet airliner? A jet airliner, in contrast to propeller based planes, comet flew above the weather, 8 miles up in the stratosphere, and provided a quiet and smooth ride. So, this is what is important. In the ordinary propeller planes, they fly at lower altitudes. It is very noisy and the ride is also generally bumpy. Now, you are able to come out of that problem. The advantage is - it is a quiet and smooth ride, and the cabin is fully pressurized. So, this is the advantage of a jetliner. And if you look at, in the first year of its operation, comet carried 28000 passengers with a total of 104 million miles. So, that is considered as quiet a success.

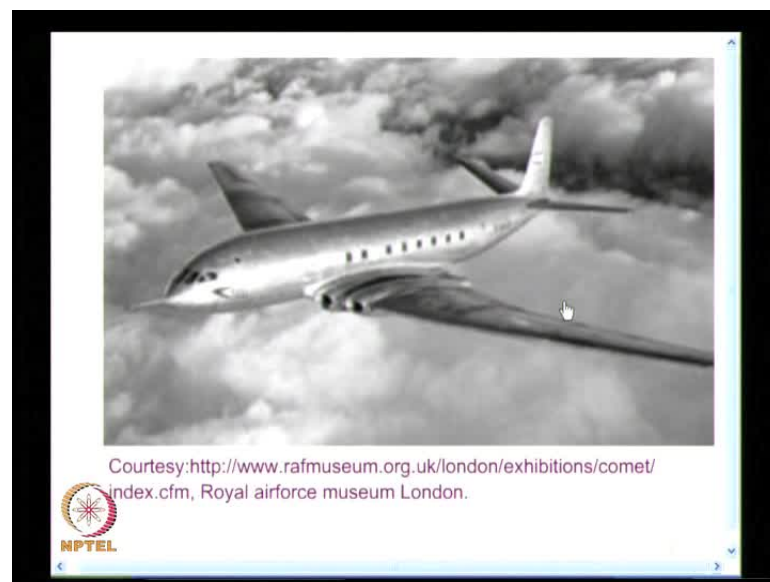
(Refer Slide Time: 02:43)

This is the overall view of the Comet aircraft, and you can see - the engines are slightly different; it is not like what you have now. And this courtesy of full a figure is from Royal Air Force Museum, London. And what was the problem? Why it failed?

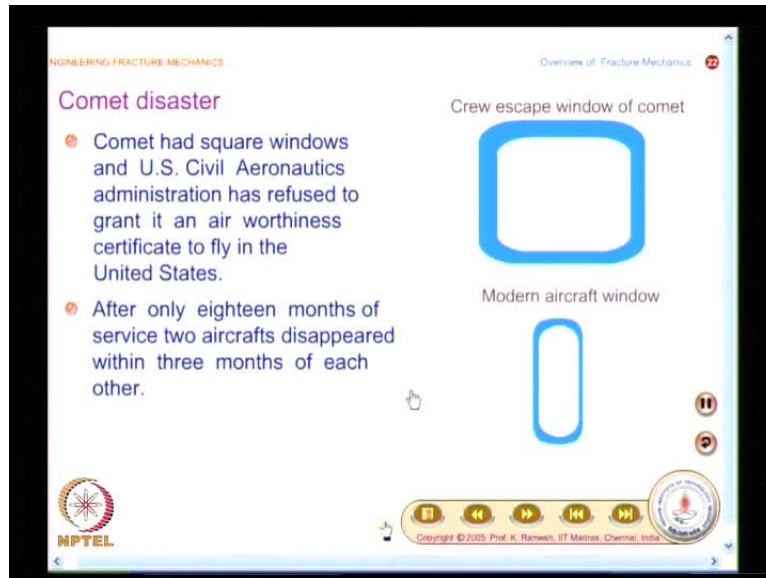
(Refer Slide Time: 03:06)

Now, if you had looked at, in the comet, you had a crew escape window which was quite large. I want you to make a sketch of this, whereas the modern aircraft, the window is narrow like this. One can wonder whether, even a small change in the shape of an opening can cause failure. In fact, for some of these, you have a gut feeling whether it will work or not. The U S Civil Aeronautics Administration has refused to grant comet an air worthiness certificate to fly in the United States, purely out of a judgment. They were skeptical about a larger opening because when you have opening, it acts like a stress concentration. So, they were quite not comfortable with it. So, they refused air worthiness certificate in the U S. Comet flew from India; it also flew to rest of the world.

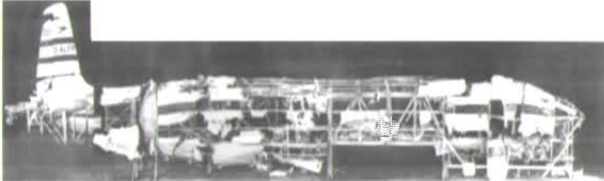
Comet disasterContd

- The confidence of the public in the Comet was undiminished until 10th January 1954 when a Comet departing from Rome plunged into sea from an altitude of 26,000 ft.
- After a great deal of effort the wreckage was salvaged which suggested that the cabin itself had failed!

In fact, there was also an accident of Comet flying out of Calcutta. With all this, the public confidence was intact until 10th January 1954. So, what happened on that day was the Comet departing from Rome plunged into sea from an altitude of 26000 feet. So, people thought, there are some problems in the structural aspect of it; that needs to be looked at because aircrafts missing mysteriously in flight was to be looked at very closely to assess the reason. So, what they did was - they salvaged wreckage from the ocean and they reconstructed the aircraft. And what they found was, to their surprise, the few salvage itself had failed; this was not imagined. Only when they recovered the debris from the sea, when they put all of them together, they found that cabin itself had failed.

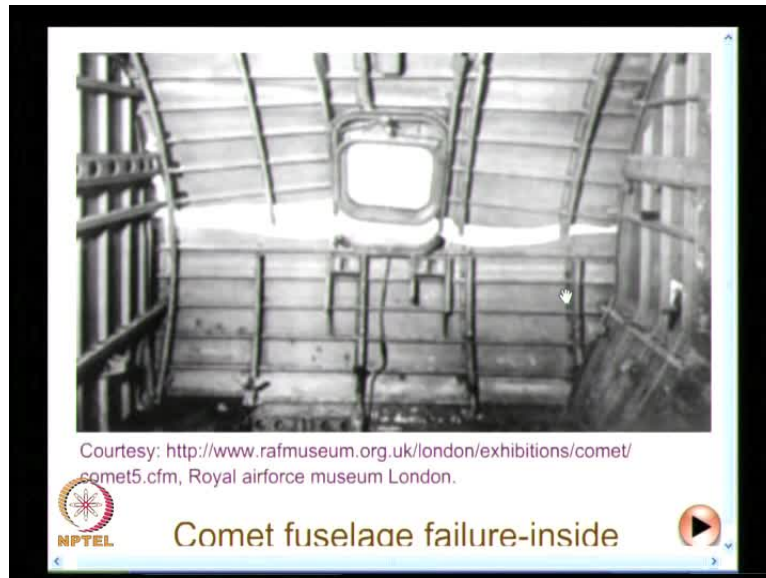
(Refer Slide Time: 10:02)

So, what happened was - after 9000 hours of equivalent flying, the pressure dropped, and a split in the fuselage was found. And where this happened? It happened near the escape window that US administration was not allowing it to fly because the size was larger than what it could be, and you had the crack propagated from this. So, once you have an opening in the fuselage, you have decompression taking place. It was only a small crack; a small crack in the corner of an escape latch window has caused the failure. So, when I have a small crack, from an actual point of view, it will behave like a crack plus link of the window.

If I have this on one of the corners, the crack may be a few millimeters, but that total crack, the way it will behave structurally would be few millimeters plus length of this diagonal. So, this is what you will have to keep in mind. You will have surprises when you are really going in for new design. In fact, the company went bankrupt because of this failure, and the beneficiary was Boeing. Boeing were also designing their planes. So, they took all the lessons from the Comet disaster; made suitable modifications in the Boeing; then Boeing became a successful airliner. So, what you will have to look at is - apart from the square windows, the testing of the new plane while still in its design phase was inadequate.

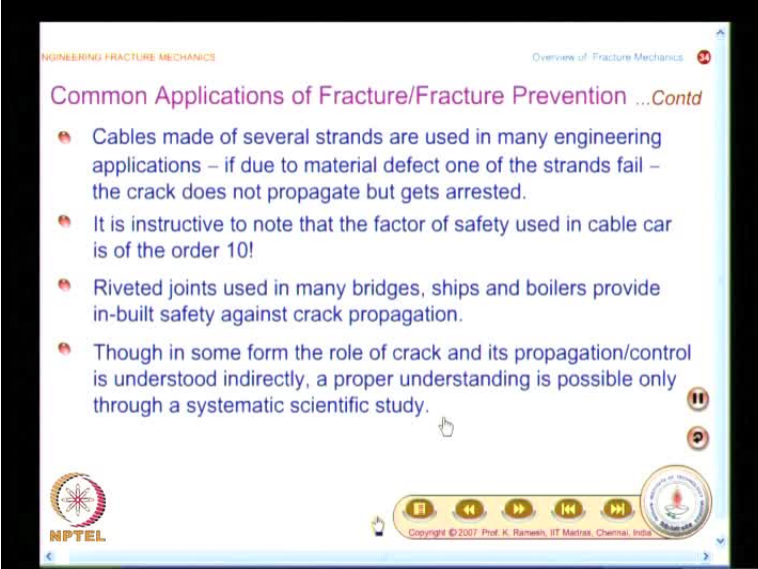
(Refer Slide Time: 31:25)

- Cables made of several strands are used in many engineering applications – if due to material defect one of the strands fail – the crack does not propagate but gets arrested.
- It is instructive to note that the factor of safety used in cable car is of the order 10!
- Riveted joints used in many bridges, ships and boilers provide in-built safety against crack propagation.
- Though in some form the role of crack and its propagation/control is understood indirectly, a proper understanding is possible only through a systematic scientific study.

And if you look at, cables made of several strands are used in many engineering applications. Why you have cables made of several strands? It is for fracture prevention; if due to material defects one of the strands fails, that crack does not propagate, but gets

arrested. See, one aspect is - when you have multiple strands, you want the cable to be flexible; it serves one such purpose; the other such purpose is - even if by mistake one strand fails, there would be some time lag before another crack initiates. So, this was the problem with Liberty failure. When the complete ship was made up welding when a crack in got initiated; it propagated without any resistance; this, they understood; they provided crack arresters and they salvaged some of the ships.
