**Manufacturing Process - I**  
**Dr. D. B. Karunakar**  
**Mechanical and Industrial Engineering Department**  
**Indian Institute of Technology, Roorkee**

**Module - 2**  
**Lecture - 10**  
**Metal Casting**

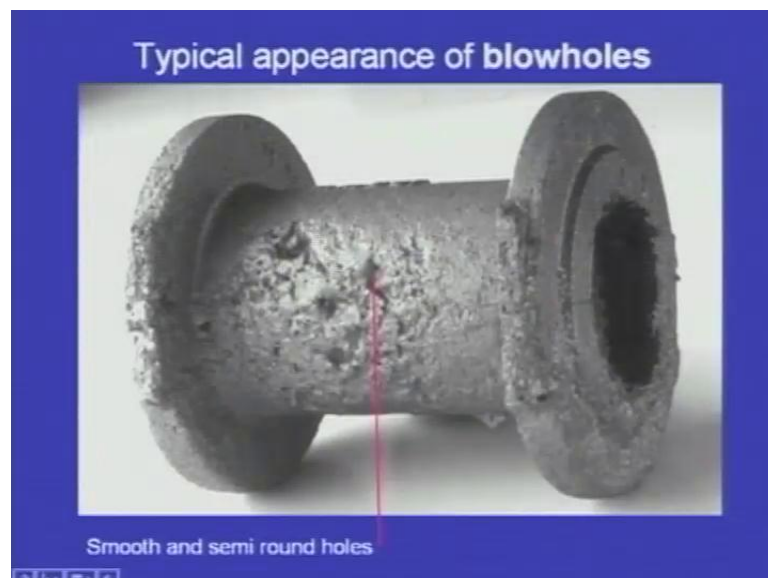
So, this is the typical appearance of blowholes, and here we can see smooth and semi round holes all over the surface of the casting. So, these are the blowholes, and what are the causes for these blowholes?

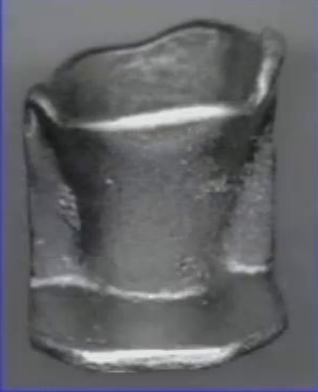
Typical appearance of Pin Hole Porosity

As the melt gets solidified, it loses the temperature and liberates dissolved hydrogen.

The main factor is the hydrogen. Molten metal absorbs hydrogen at two places: one place is in the furnace; in the furnace there is heat; when we melt the metal, the molten metal absorbs the hydrogen in the furnace. Again, when we pour the molten metal into the cavity, there is moisture - that is the water, that is the  $H_2O$  - this will be disassociating into hydrogen and oxygen, and this hydrogen is absorbed by the molten metal, and this absorbed hydrogen will be inside the molten metal, and it will be going inside the cavity.

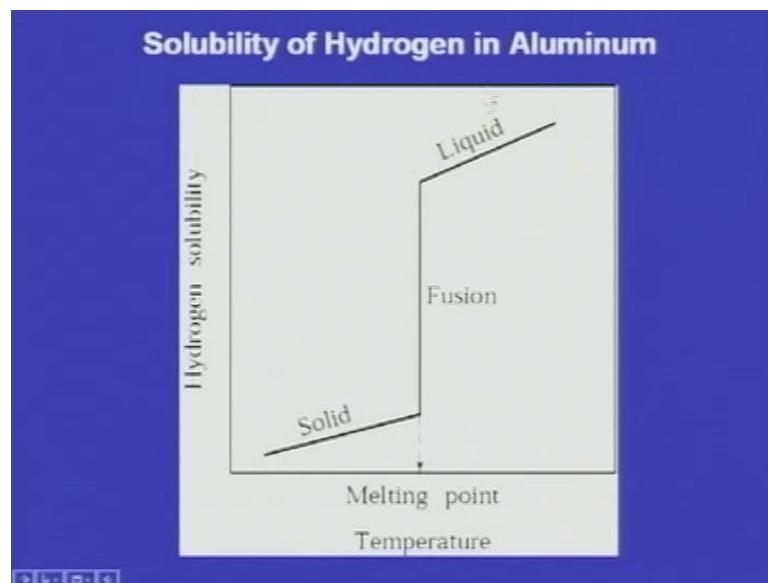
And let us see the solubility of hydrogen in aluminum. At the liquid state it is very high, and at solid state the solubility is drastically coming down.

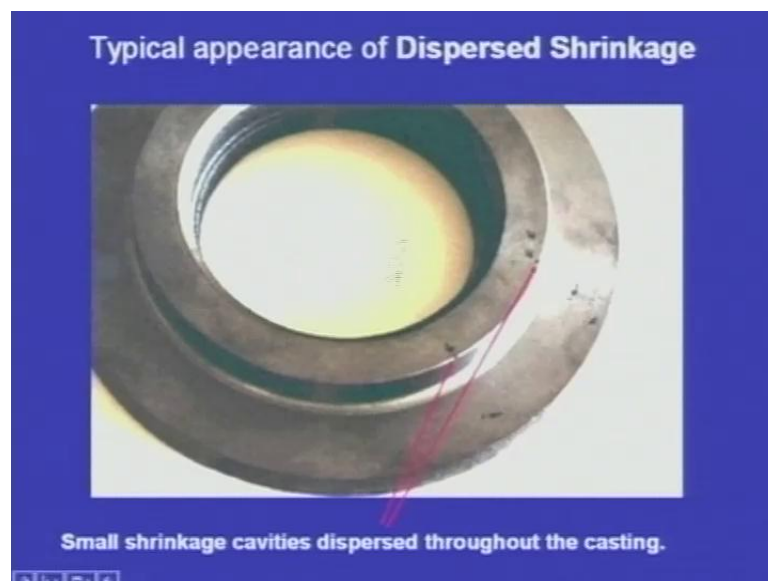
And this is the typical appearance of dispersed shrinkage. We can see small shrinkage cavities dispersed throughout the cavity, and these cavities will be generally one centimeter deep; they will be dispersed at some places.

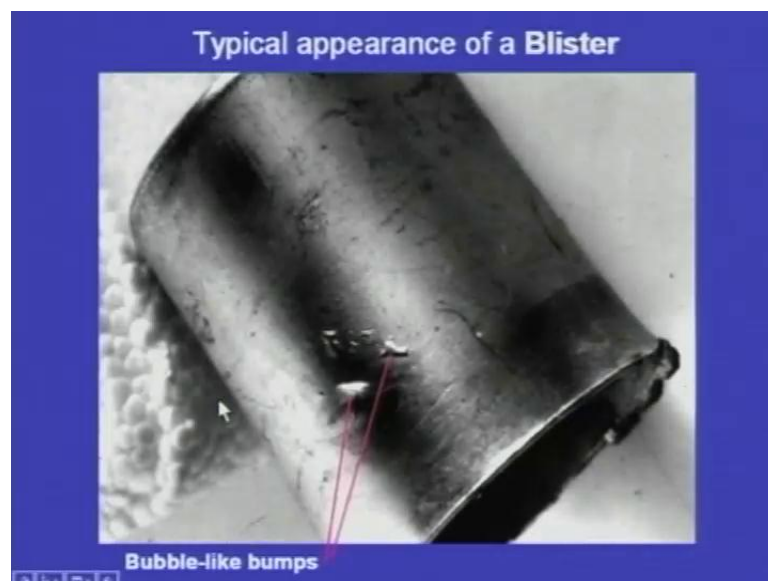
And this is the typical appearance of a blister, and here we can see bubble like bumps, here one bump, and here one bumps, and some more bumps; bubble like bumps are formed at some surfaces. And what are the causes for this blister?

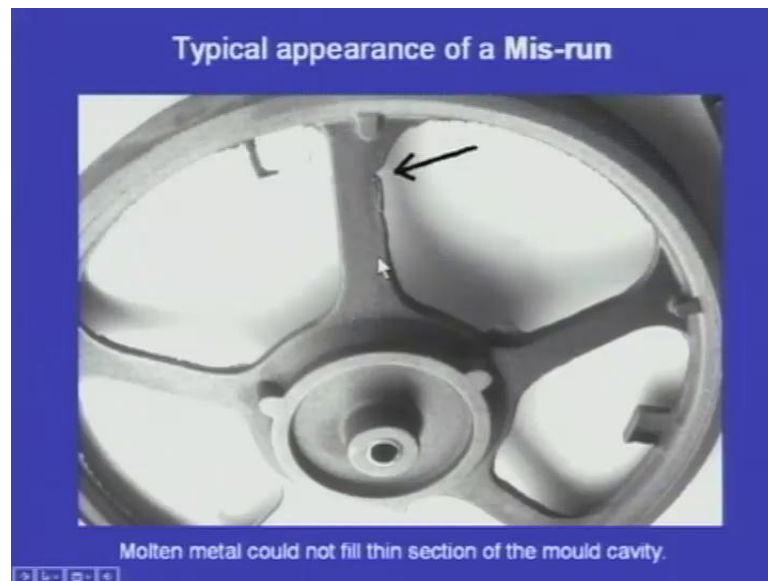
So, this is the typical appearance of a mis-run and here we can see a casting - wheel type casting - and here we can see five ribs, and this rib is not properly cast; the molten metal could not fill in this rib. What are the causes for this defect?

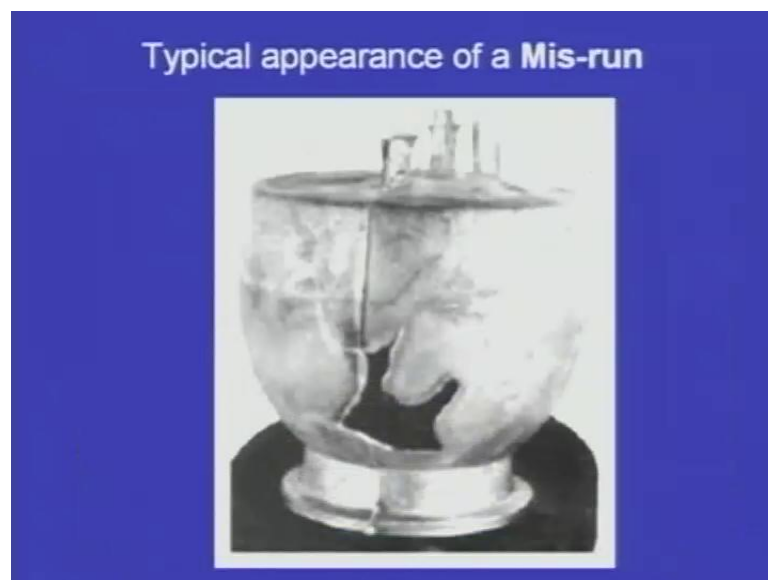
And here we can see another casting, and here we can see there is a gap. Again here the molten metal could not enter in to this thin section.

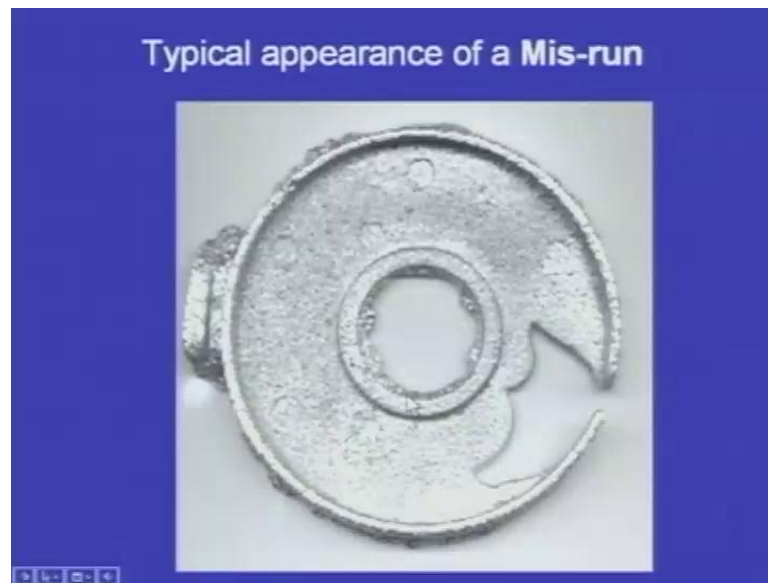
Let us see another casting. And this is another casting. Again, the molten metal could not enter in to this small section.

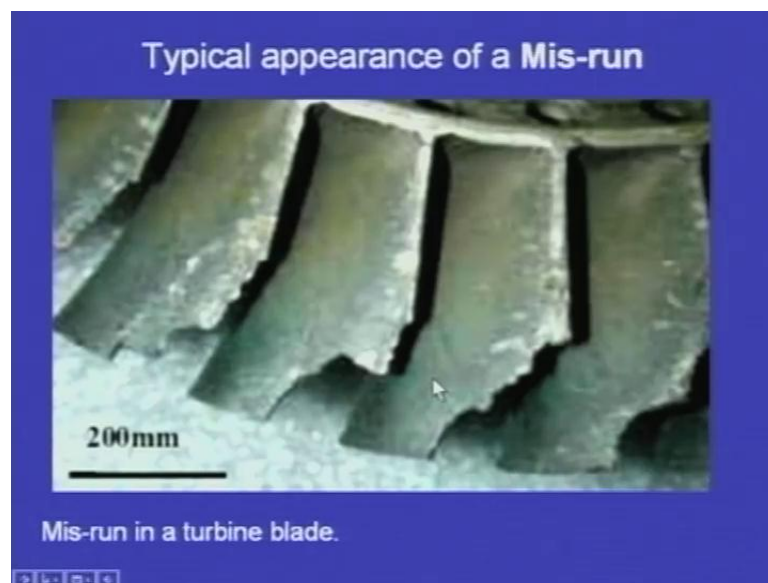
Let us see another casting, and this is a turbine blade, and this turbine blade is manufactured by casting. And here we can see this turbine blade is thin section - thin sectioned casting - and we can see every blade, at some locations, the molten metal could not fill the cavity. Here there is a gap, and here there is a break, and here there is a break, and here there is a break. That is at several places molten metal could not enter in to the small section cavity

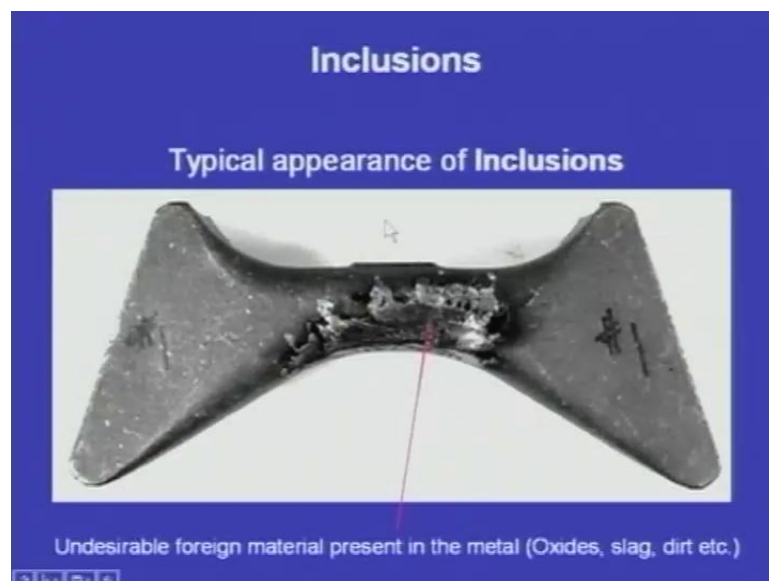
And this is the typical appearance of inclusions. Undesirable foreign material is present on the surface of the casting, and when we remove these oxides or this foreign material, there will be discontinuity in the casting, and that is a defect, and we call this defect as the inclusion. Most of this times these foreign materials will be oxides and slags present in the molten metal.

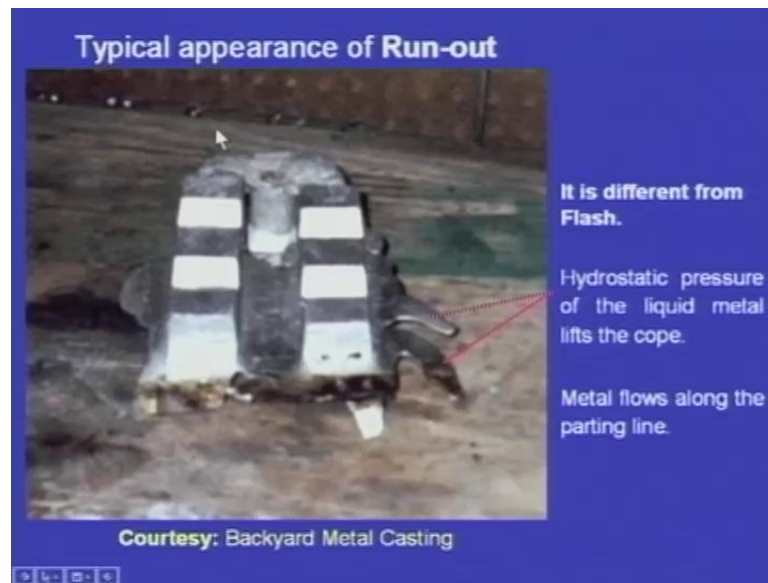
(Refer Slide Time: 33:23)

This is the typical appearance of run-out defect and this is different from flash. In the case of the flash, the molten metal has gone in unwanted areas along the parting line, because the molding sand is not properly compacted, there is a gap along the parting line between cope and drag; that is why the molten has gone inside.

Here though the molding sand is compacted properly along the parting line, the defect is arising; some molten metal is flowing outside along the parting line. The hydrostatic pressure of the liquid metal lifts the cope. Then the molten metal will be going out along the parting line.

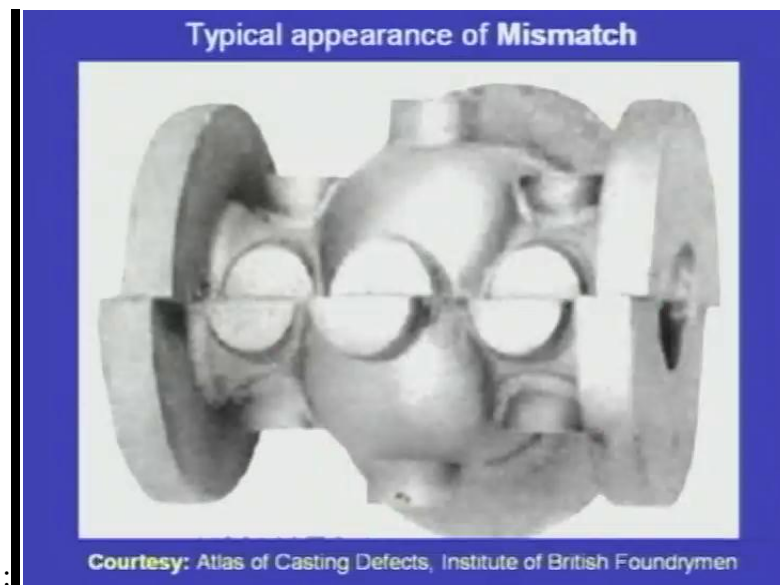
(Refer Slide Time: 37:16)

And before that, we can see another casting; this is another casting, where the similar problem of mismatch has occurred.

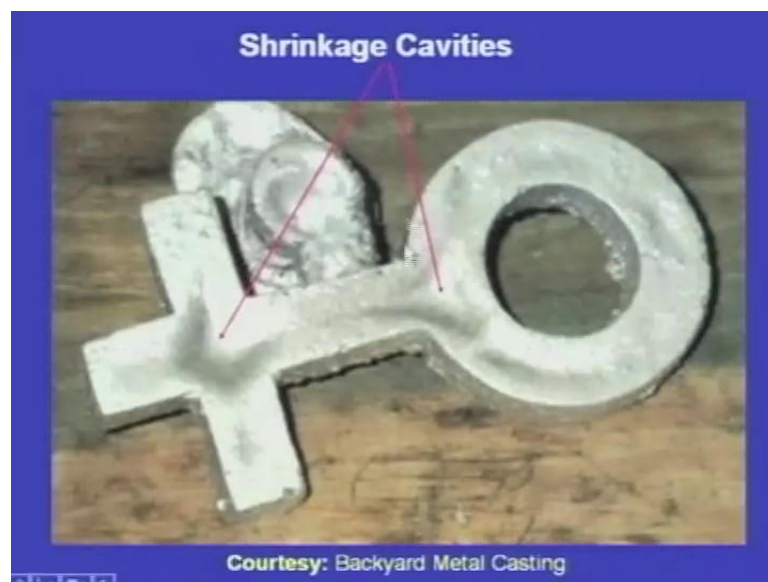
(Refer Slide Time: 43:54)

And here we can see a casting with out any riser, because there is no riser, there are shrinkage cavities; here we can see one shrinkage cavity, and here we can see one shrinkage cavity, and here, and here, there are shrinkage cavities due to the options of riser.

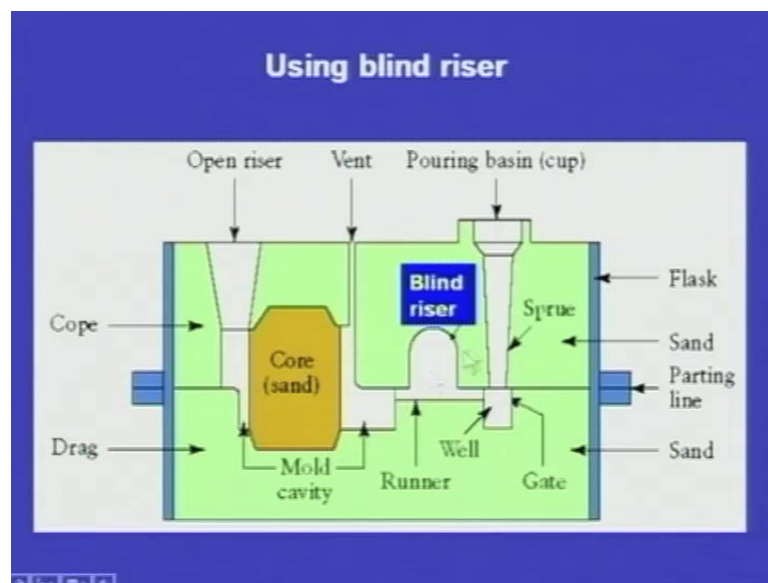
(Refer Slide Time: 50:10)

Next one - by using blind riser we can prevent shrinkage cavity. What is this blind riser? So, this is a mould, and this is the drag, and this is the cope, and this is a open riser, this is a vent hole, and this is the sprue.

And the open riser, the problem is here this area is exposed to the atmosphere; then heat dissipated to the atmosphere. So, because of that it will be freezing quickly. On other hand, there is a blind riser, which is totally inside the mould. Like the open riser, it is not

exposed to the atmosphere. So, less heat goes to the mould wall. So, the metal in this blind riser will be in liquid state for prolonged time, and if there is any shrinkage cavity the liquid metal from the blind riser will be compensating that shrinkage cavity. So, by using blind riser, we can prevent shrinkage cavity.
